**REQUEST FOR QUOTES (RFQ)
#2011-02
WITH
QUALIFICATIONS-BASED
SELECTION (QBS)**

**CONTRACTOR/
REHAB CONSTRUCTION
AFFORDABLE HOME PROJECT**

HOME INSPECTION

An inspection of the home at 4162 Bobwhite Drive in Nashville was conducted on August 18, 2011. All major components of the home were inspected. Major components include: roof, framing, foundation, electric, plumbing, and heating and air. The weather conditions at the time of the inspection were partly cloudy with temperatures in the 90s. The homebuyer was not present at the time of the inspection. The repair list begins on the following page. We recommend that licensed or qualified professionals make all repairs.

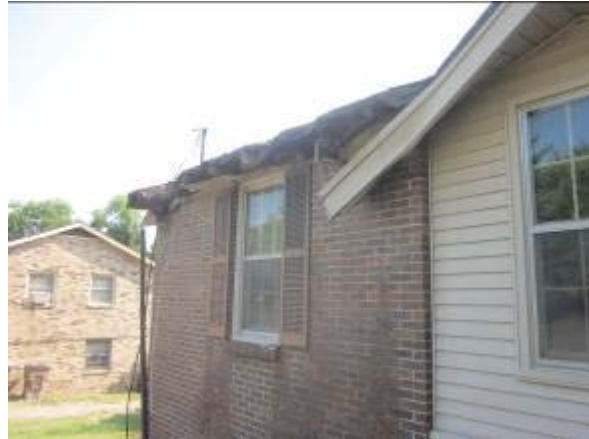
Damage was noted to the roof, soffit, and gutter at the front left corner of the home. Repairs are needed to prevent water from entering this area. I recommend tarping the area off until the repairs are made.

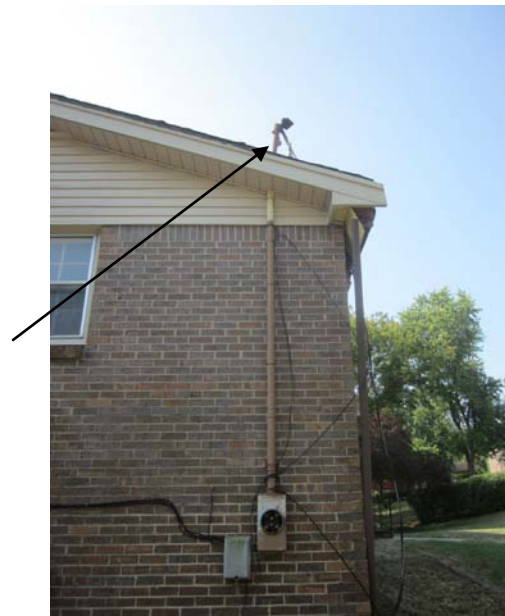
The electrical service mast is bent. Apparently a tree fell on the electrical line and pulled the mast toward the road.

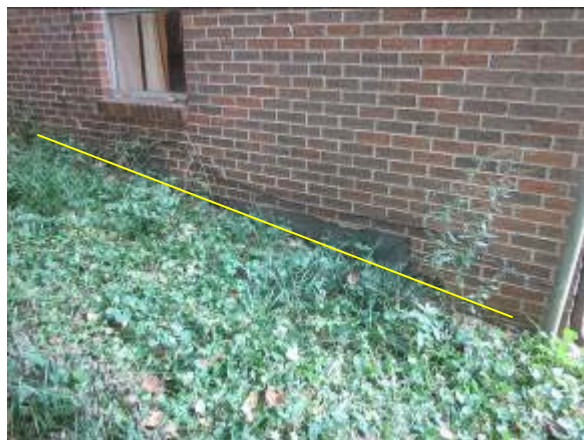
I recommend adding dirt against the exterior walls of the home. The dirt should be sloped away from the home to help direct water away from the home. A good rule of thumb is to have 6-inches of fall in the first 10-feet from the exterior wall of the home. Elevated moisture levels were detected on the right foundation wall and front foundation wall in the basement.

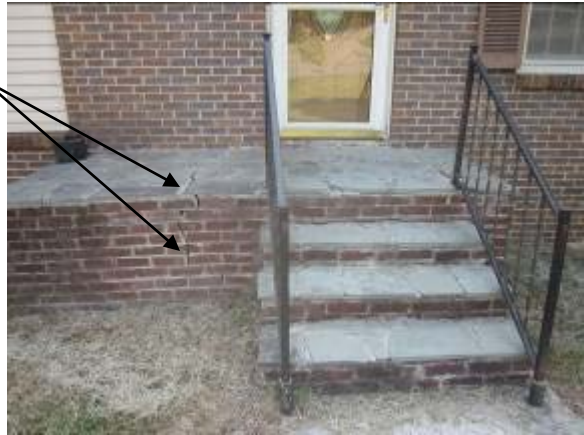
A large crack was noted at the front porch. The crack runs from the front wall of the porch across the surface of the porch.

The stone pieces on the surface of the front porch are loose.

The railing at the front porch steps is loose.

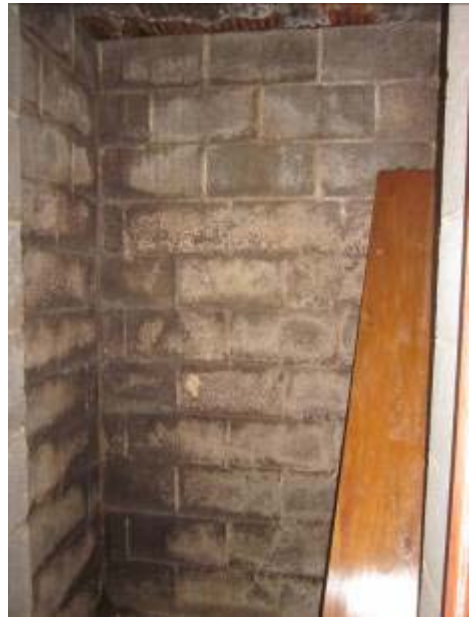
Water is entering the basement around the front porch. Some of the water is seeping through the block due to the exterior grading. Water is also running in through the crack on the surface of the front porch.

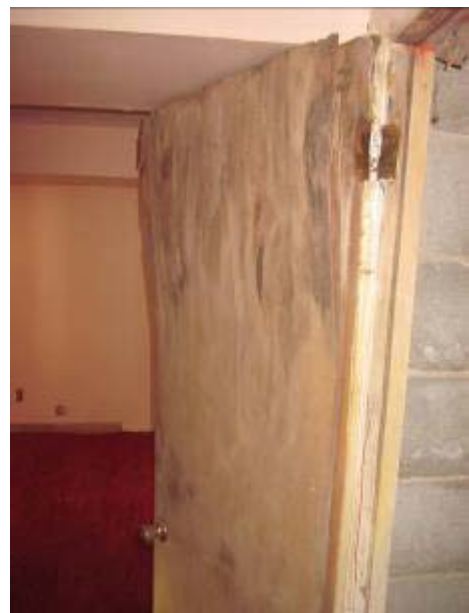
The door to the basement closet below the front porch is rotted and the hinges are rusted due to water entering through the front porch.

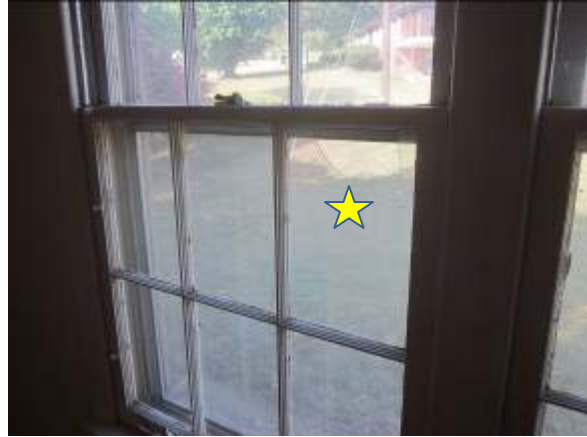
Broken glass was noted at the top sash of the left front living room window.

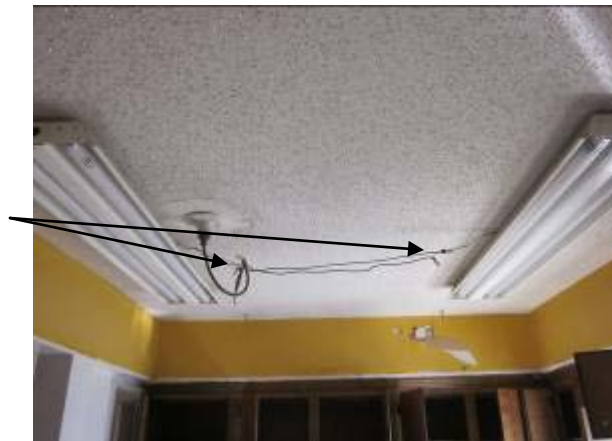
Spliced wires were noted at the ceiling lights in the kitchen. I recommend having a licensed electrician check the lights to make sure they were properly installed. The splices should be enclosed in a junction box.

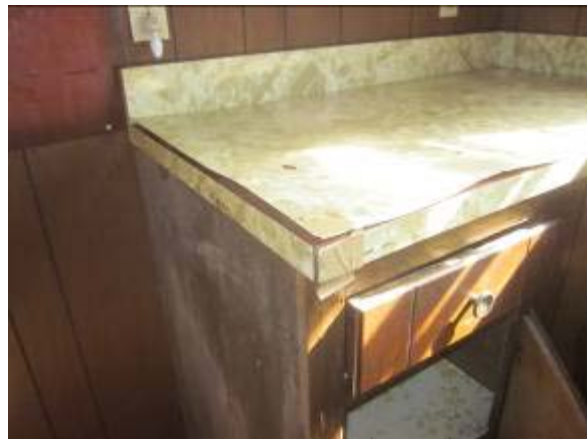
- Loose wires were noted at the front left corner of the basement. The wires are coming out of the basement wall.
- I recommend having a licensed electrician look the electrical panel over. Several minor repairs are needed inside the panel.

The kitchen counter tops are in poor condition.

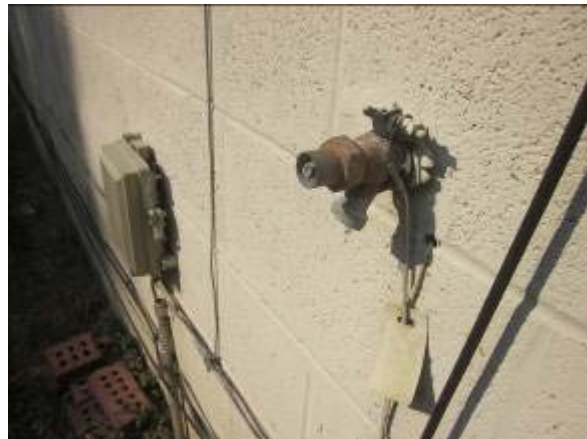
- Several of the baseboard heaters have missing parts or are bent. These heaters can be a fire hazard if they are not functioning properly. Once it is determined that the HVAC unit is functioning properly I would have the baseboard heaters removed.

The control knob to the rear exterior faucet is missing.

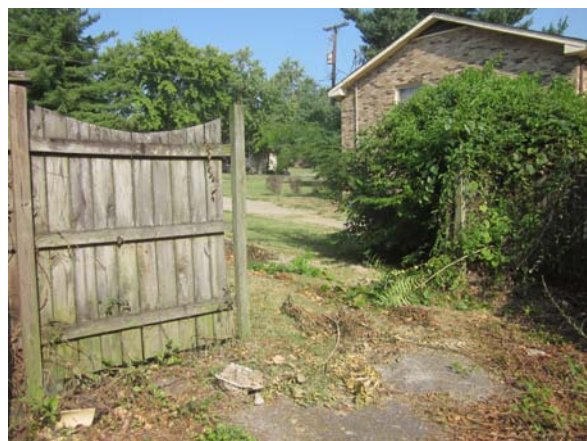
The fence gate on the left side of the home is missing.

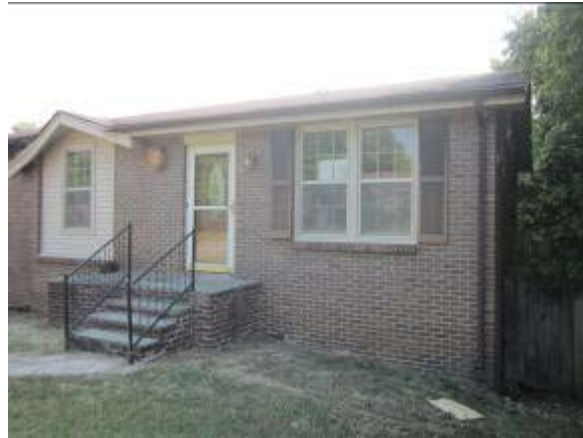
Porch- The front porch is concrete. The surface of the porch is covered with concrete. The front porch has a brick face and stairs. The handrails are wrought iron.

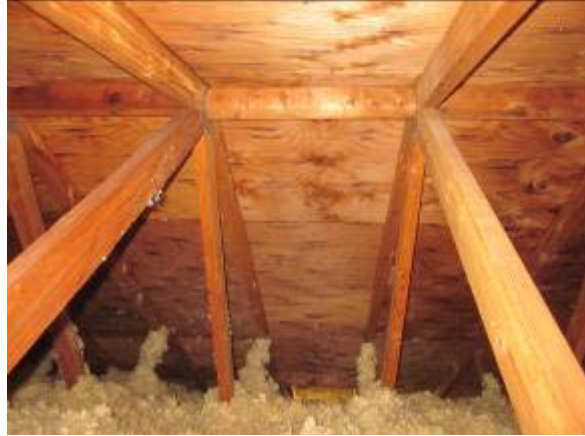
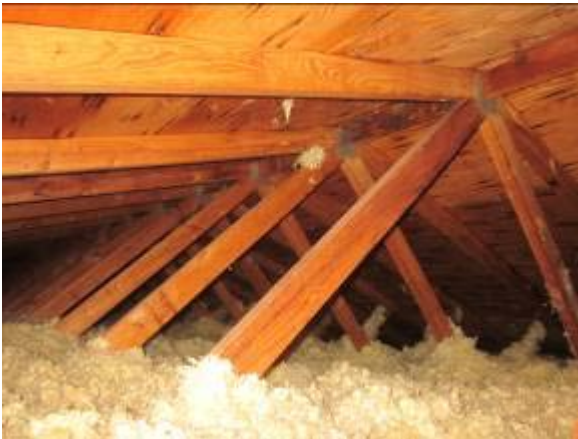
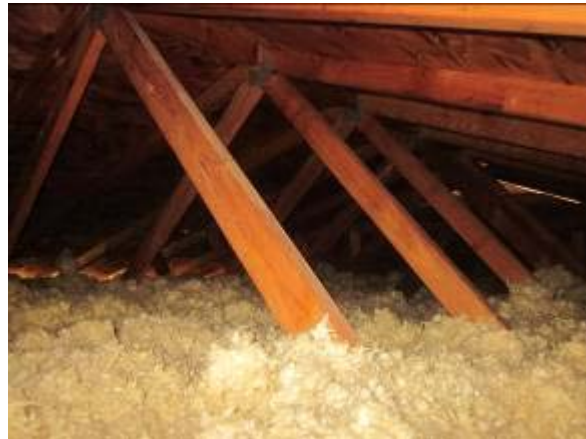
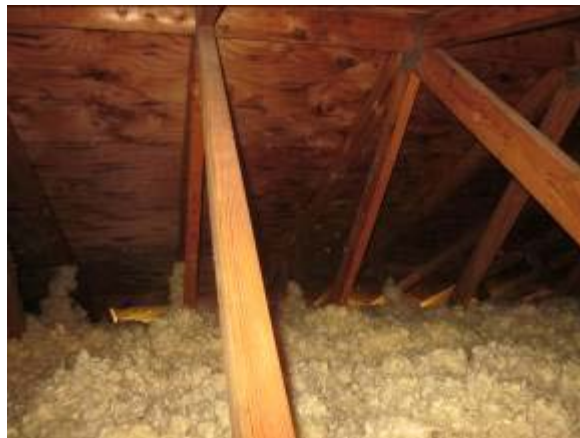
Comments- Water stains were observed in the decking in the attic. No wood moisture could be detected in the wood at the time of the inspection.

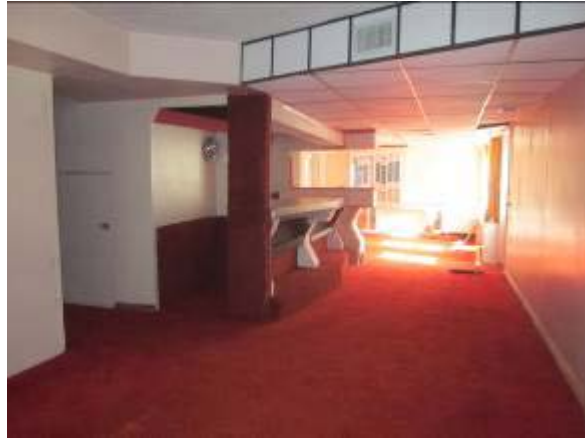
Evidence of Water- Moisture readings were taken on the foundation walls of the basement. Elevated moisture levels were detected in the front and right side foundation walls.

Joists / Girders / Supports- 2x8 floor joists on 16-inch centers along with triple 2x10 girders were used in framing the floor system. The floor system is supported by steel posts and load bearing walls.

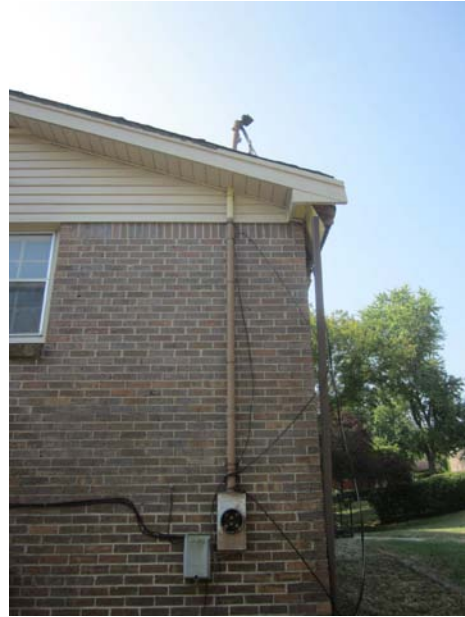
Electricity (Service, Outlets, Switches)- The service feeding the home is above ground. It is approximately 200 amps @ 120/240 volts. The main electrical disconnect is located in the electrical panel in the basement. Overload protection is provided by breakers. It is recommended that the breaker panel be adequately labeled. In case of an emergency you should familiarize yourself with this panel.

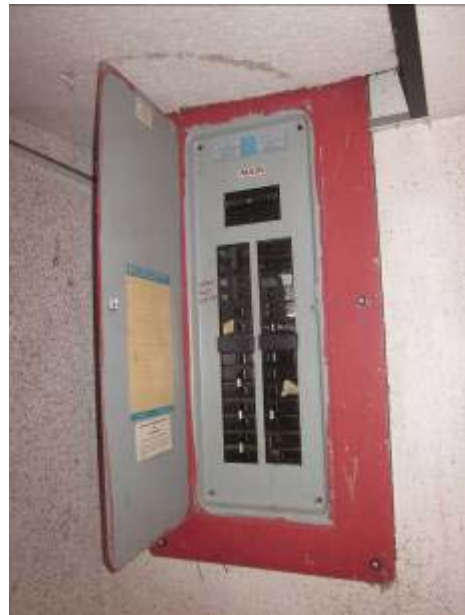
Comments- The electric meter has been removed. Therefore I was unable to test outlets and switches.

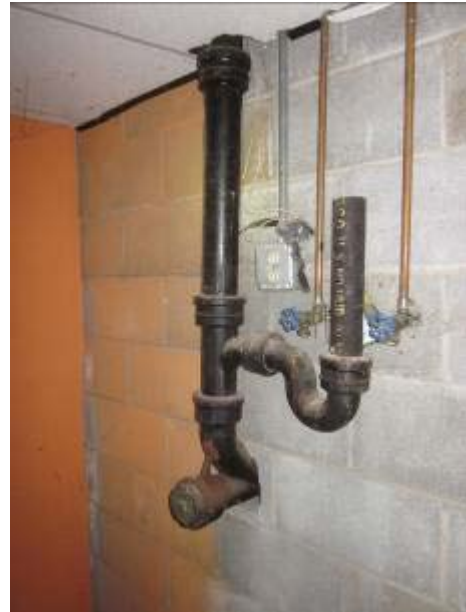
Plumbing- The home is supplied with city water. The waste lines appear to be connected to a sewer system. All readily accessible plumbing pipes throughout the home, including supply and drain lines, were inspected. Copper supply lines were noted along with steel ductile and PVC drain lines.

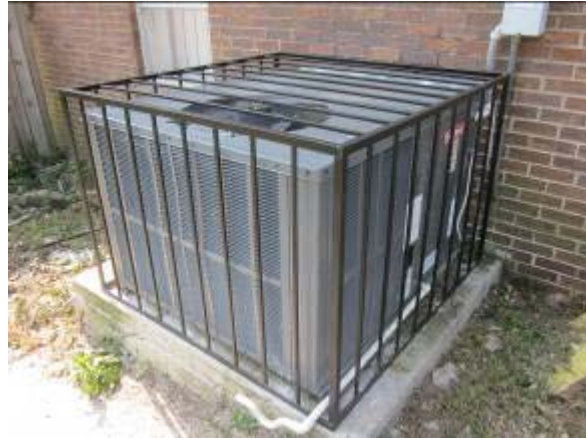
The heating and air unit was manufactured by Goodman Manufacturing Company in 2009. It is a 3.5-ton electric packaged unit. The unit supplies the home with electric heating and cooling. This unit is adequately sized for the amount of square footage it is heating and cooling. This unit is also equipped with a heat pump. A heat pump is basically a compressor-cycle air conditioning system that can operate in reverse. As long as the unit is functioning properly in either the heating or cooling mode, it is a good indication that the major components (compressor, fan, and coils) are functioning properly. Adequate airflow is important to the efficiency of these units; filters should be kept clean. The service disconnect is located above the unit on the exterior wall of the home.
